Deciphering Concord's Old Stone Walls and What They Indicate: *A Field Guide*

RICHARD T. T. FORMAN

Concord Land Conservation Trust
Special Publication
Concord, Massachusetts
2022

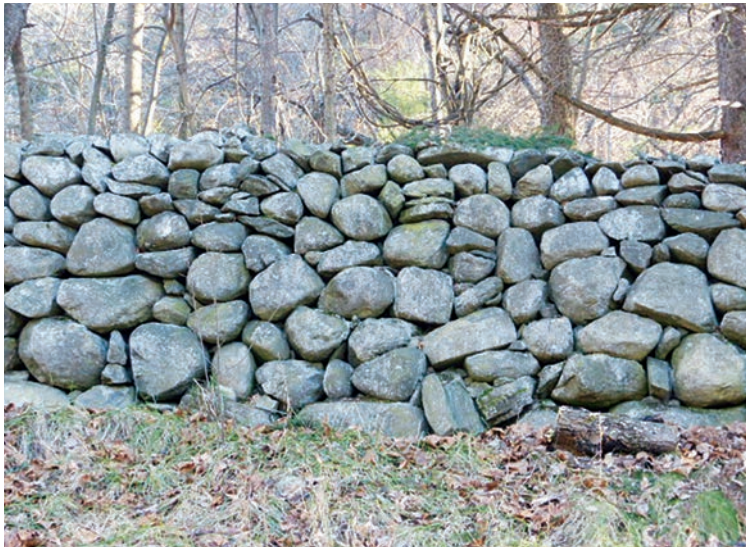
Figure 1
Stonewall for bull (or
sheep). Flattish basal
stones; vertically, large,
medium, and small
stones, partially stacked;
6+ feet high. East St.,
Carlisle.

Cows seldom climb or jump. But tall hefty walls (Figure 1) are needed for a bull (see impressive Hunt-Hosmer farm wall in mid-1800s painting in the Concord Museum). High walls restrain sheep that climb. Also horses that jump. Horizontal poles or trunks atop the stones may have been common for bulls, sheep and horses, in addition to a good many town roadside walls. See the replica of an old corral periodically used by cattle on drives (Figure 4). Only once have I found horizontal poles topping an old stonewall in town. But they were recent. Barbed wire, sometimes remaining on today's old stonewalls, didn't become widely available until perhaps the 1880s. Of 27 photos I examined of Concord stonewalls in ca.1880 to 1920, only one 1920 photo showed wire fencing.

The shapes of stones in Concord of course also vary. Glacially rounded stones seldom have a length-to-width ratio > 3. Large elongated stones are often set transversely, along with flattish stones, at the base of stonewalls (Figure 1).

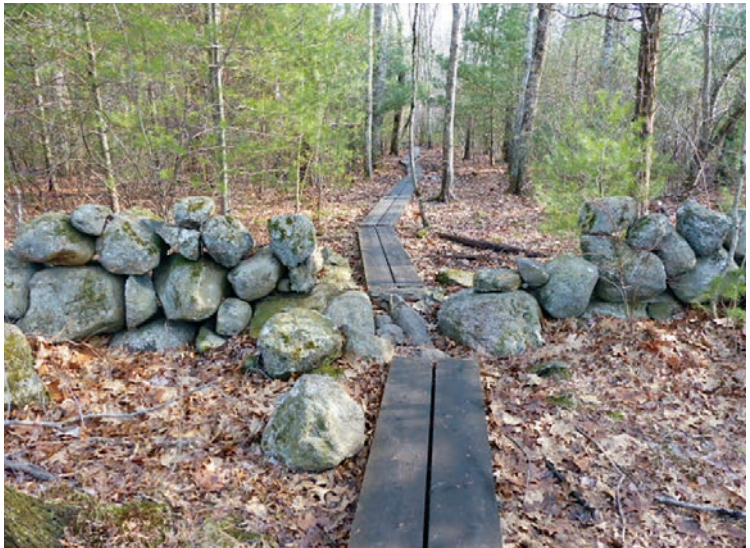
Figure 2
Pasture ("Single")
stonewall. Large and
medium-size rounded
stones, indicating the
original farmer's land
clearing. CLCT (Concord
Land Conservation Trust),
Newbury Field.

Pasture walls keep livestock in or out of valuable spaces. Normally these walls are composed of large glacially rounded stones, about two feet or a bit more in average diameter, visible along the bottom (Figure 2). Such stones are readily moved by one or two people. Medium-size stones usually predominate in the middle wall level and small rounded stones a foot or less in diameter sometimes still remain on top. A basal layer of large flattish and oblong stones often lies buried by the wall’s weight. Old stonewalls are normally built with few if any small exterior stone wedges or chinks (Figure 2), which readily fall out in the endless freeze-thaw cycles.

In cross section, the pasture stonewall forms a tall triangle, with the stones carefully fit together. Lichens commonly thrive on stonewalls, particularly on the upper stone layers remaining. No jumble of stones. The structure may last for centuries, barring a rare event such as the strong 1755 Cape Anne earthquake, which flattened nearby walls, or humans removing stones or later machines obliterating stonewalls.

In most built areas, old pasture walls (Figure 2) almost disappeared. Still, impressive old pasture walls remain abundant in many natural areas.

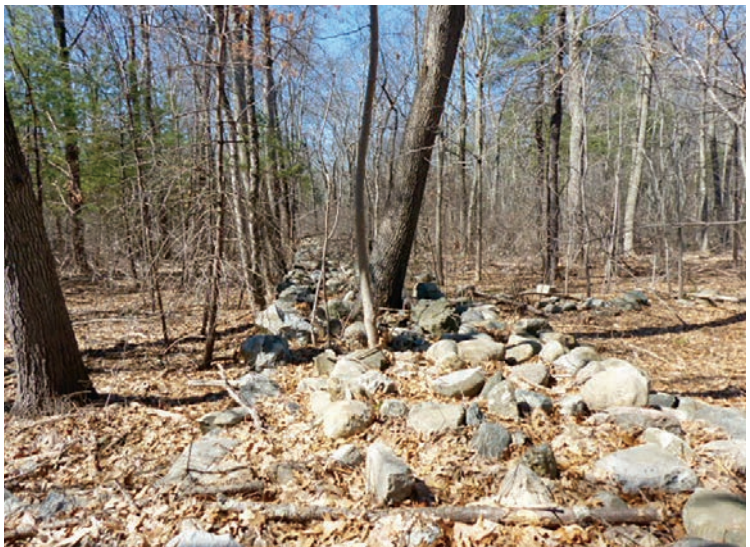
Figure 3
Cultivation ("Double")
stonewall by flat area.
Foreground wall partially
cannibalized (stone
removal), background wall
intact. Harvard's Estabrook
Woods, Concord.

In contrast, the original cultivation stonewall contains two rows of large and medium rounded stones, separated by a “V” trough filled with small rounded stones (Figure 3). This wall adjoins a crop field, or even a vegetable garden. A unique sequence explains the unusual wall form. The farmer plows the field and produces a crop. Fall and spring frosts penetrate the bare soil. Repeated daily freeze and thaw cycles in the top foot or so of soil gradually raise small stones upward (ice expands pushing soil and stones upward; then melting washes soil particles downward faster than stones). In spring, the farmer removes the new small stones on the surface and dumps them in the stonewall trough. After perhaps a decade of this farming and natural cycle, the top layer of soil is free of small stones. Thus cultivated fields produce two useful crops—stones and plants.

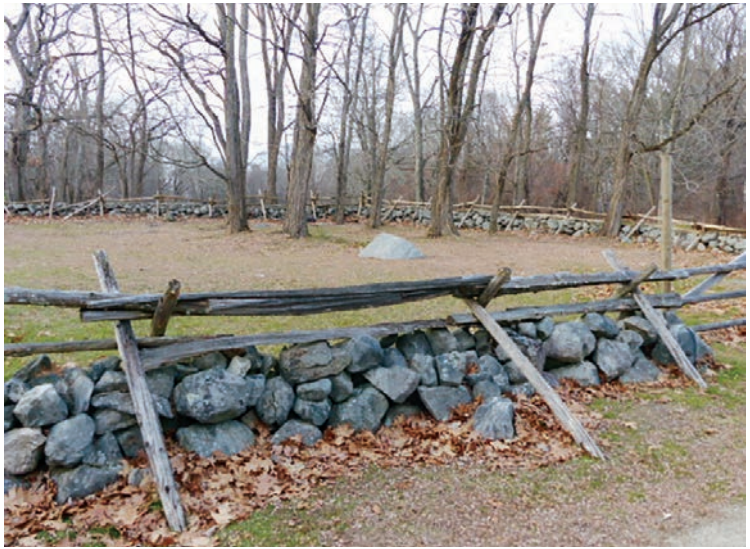
Figure 4
Livestock corral with
wood framework. Recent
reconstruction; many
granite stones. USNPS
(U.S. National Park
Service) next to 1700s
Hartwell Tavern, Lincoln.

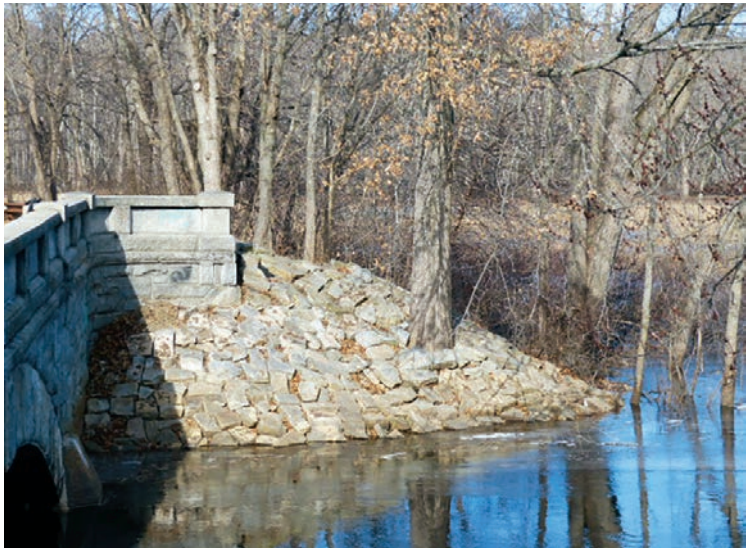
Figure 5
Retaining wall for bridge,
downriver side. Many
slabs (flat stones) from
an outcrop quarry; river
foreground; flooded
floodplain background.
CLCT French's Meadow.

Retaining walls of stones that hold back soil play many roles. Bridge support (Figure 5). Big barn foundations. Small farmhouse foundations and cellar holes. A dam. The uphill cut-slope by a road. The road's downhill fill-slope. Groundwater and subsurface water readily flow through a stones-only retaining wall, so the wall doesn't fall, and soil doesn't slump.

Retaining walls (Figure 5) are built where different surface levels immediately adjoin. Corral stonewalls are close to barns. A short cultivation stonewall suggests vegetable garden near a house (e.g., by an 1800s house foundation, Route 2A east of Merriam’s Corner). A small isolated pile of small rounded stones (Figure 12) also probably often indicates a vegetable garden close to home (e.g., near Borz Bog Meadow).

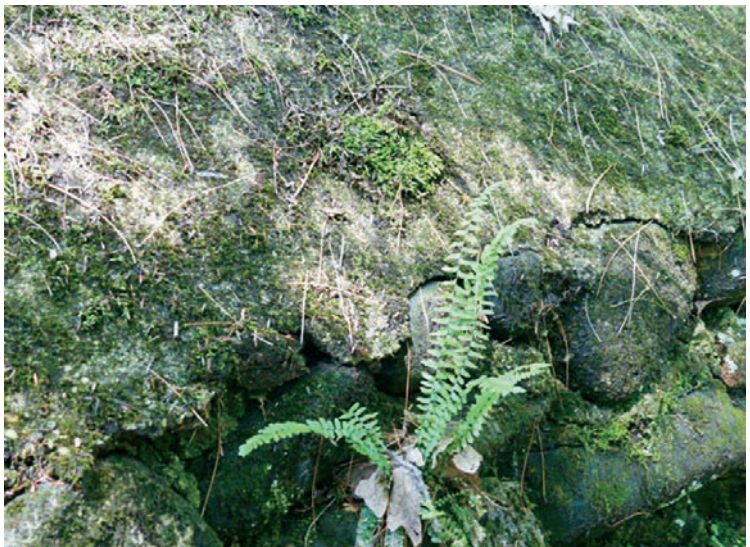
Figure 6
Cement-covered roof
and mortared stonewall.
Early 1900s boathouse;
lime-adapted spleenwort
fern and mosses. CLCT
October Farm Riverfront.

Masonry walls (Figure 6), with stones held together by mortar or cement, were probably sparse here until the 1800s. Marble was locally mined for lime in the Estabrook Woods and farther south on land now in Lincoln.

Micro-environmental conditions along a stonewall, especially on the moist side, favor many vascular plants, mosses, and invertebrates. Accumulated leaves help form soil. The cement or mortar of masonry walls supports locally uncommon lime-adapted lichens and mosses, even spleenwort ferns (Figure 6). In pastures, biodiverse hedgerows form along stonewalls.

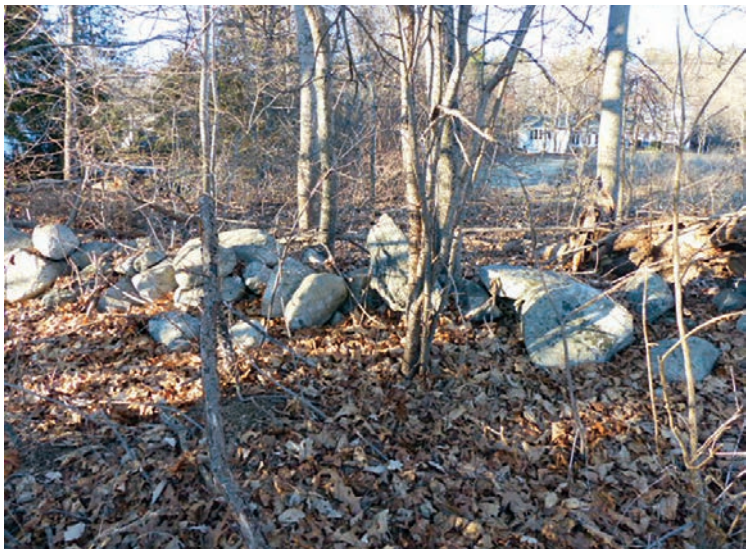
Figure 7
Machine-made wall.
Imported huge and large
stones, rounded and
quarried; with piled-up soil;
on river floodplain with few
stones. Town of Concord's
Barrett's Mill Farm.

Machine-made walls (Figure 7) using tractors and other motorized equipment likely spread in the early 1900s. With no clear structure, these walls include soil and huge stones.

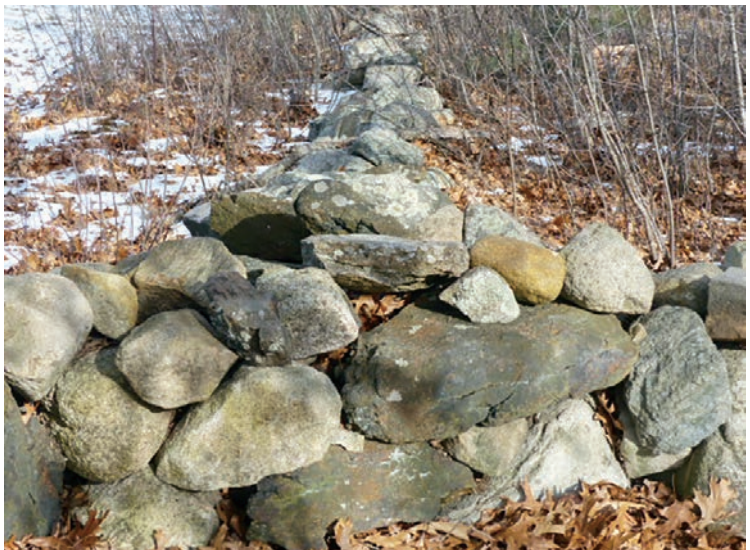
Figure 8
Diverse stone types
illustrated at T-intersection.
Gneiss, granite, one
brown quartzite, and
dark metasediment or
metabasalt stones. USNPS
Battle Rd., Lexington.

So, looking closely at stonewalls here commonly reveals a mix of igneous granite and basalt stones, plus metamorphic gneiss stones, usually all rounded in a glacier (Figure 8).

What can we interpret in the stonewall network? “T” intersections (Figure 8) usually mean the long wall is older, and the perpendicular wall younger. That’s the same for hedgerows in open country. But look closely to see whether the stones of the two walls are dovetailed together, suggesting the same age. A rectangular or square “pound”, for temporarily holding farm animals caught after disappearing (Figure 10), may or may not be connected to the large network.

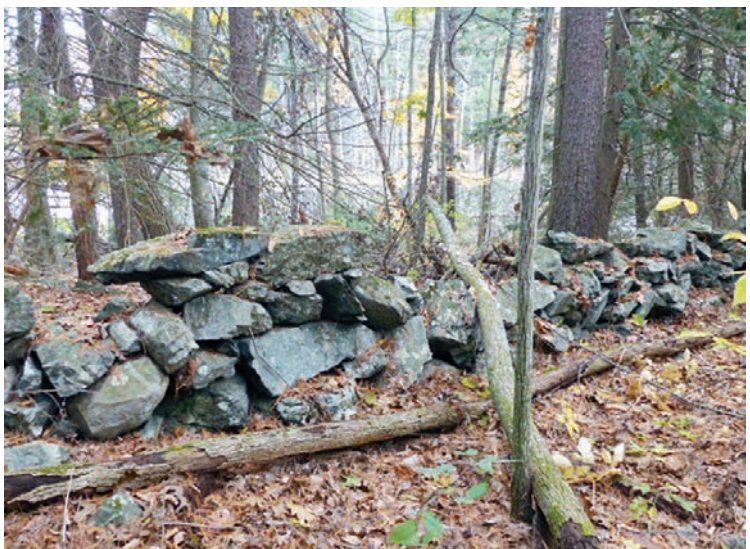
Figure 9
Wall of sharp-edged
flat-sided stones. Crudely
stacked wall structure;
from adjoining bedrock
outcrop. Fallen trees tend
to flatten a stonewall.
Mount Misery, Lincoln.

Sharp-edged flat-sided stones appear in abundance in a few walls. These stonewalls are usually near a southeast rocky cliff (Figure 9), or where people have been breaking rock or stone. Rock-splitting before the late 1700s used ice, fire, or gunpowder. Afterward, hammered “pins” left rows of 2–5” holes in stones. From the 1870s, pneumatic drills made long holes. A quarry, such as Concord’s lime-quarry pits and copper-mine cliff, produces broken stones from bedrock. Erratics were sometimes sliced or broken, as at Mattison Field and other local spots. A road cut through bedrock, such as by Lowell Road close to the town center, or a dynamited Fairhaven Cliff site, produces lots of sharp-edged flat-sided stones.

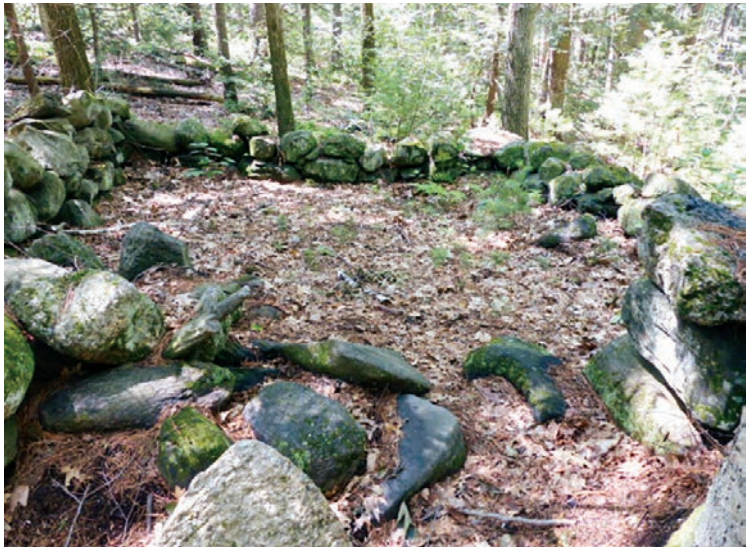
Figure 10
Pound for stray farm
animals. Granite, gneiss,
and other stone types.
Near river and extensive
wet floodplain hazardous
to livestock. Town of
Concord's October Farm
Riverfront.

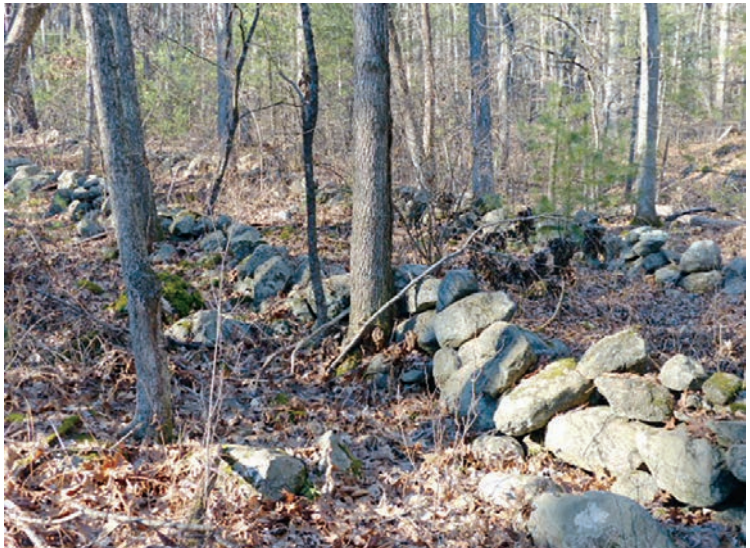
Figure 11
Parallel stonewalls forming
cow corridor or lane.
Connects seasonal cow
pond with farmstead and
pasture; granite and gneiss
stones. CLCT Upper
Spencer Brook Valley.

surprisingly common. Some function as a corridor for livestock movement to water (Figure 11). Others adjoin old wagon roads through woods and fields. Still others parallel the town’s main roads, such as the USNPS Battle Road. Two Rod Road, an old wagon road to the north, is 33 ft wide, i.e., two rods. Livestock corridors in Annursnac Woods and Upper Spencer Brook Valley are basically that same width. Henry Thoreau, the Concord surveyor, used a folding surveyors chain four rods long.

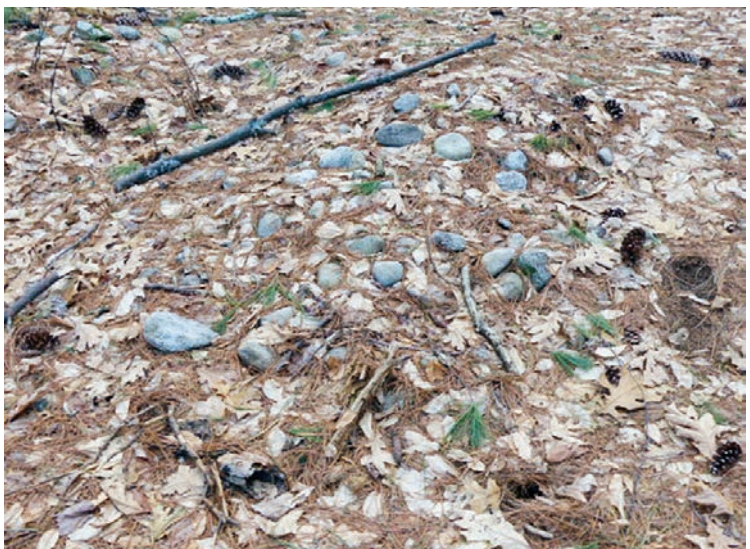
Figure 12
Pile of small rounded
stones from clearing a
small plot. Probably below
a vegetable garden by a
relatively recent (late1800s/
early 1900s) farmhouse.
CLCT Miller Farm.

(1) Thin vertical-sided walls (Figure 14); (2) walls with large, medium and small stones at all levels (Figure 14); (3) low walls (Figure 15); (4) many quarried cut rocks in wall, a few with drill marks. (Figure 16); (5) neglected walls, now a much-widened strip of stones (Figure 3); and (6) cannibalized walls, now a strip of mainly small rounded stones (Figure 13); (7) high walls for sheep; (8) narrow short cultivation walls for vegetable gardens; and (9) small isolated mounds of small rounded stones (Figure 12) often from vegetable gardens.

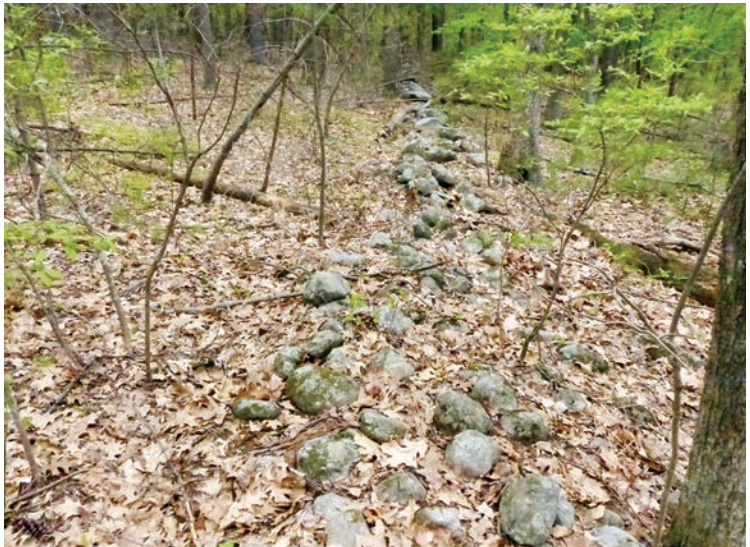
Figure 13
Cannibalized cultivation wall. Most large and medium stones removed, leaving central row of smaller stones; adjoins former tillable area. South of Bateman's Pond.

rows across town. Stonewall cannibalization, the removal of stones for other uses, ensued in earnest (Figure 13).

Cannibalization of Concord's original wall network over such a long period leaves us with but a skeleton of its extensive grandeur. Old cultivation stonewalls, such as remain in Estabrook Woods (Figure 3) and Baptist Brook Woods, are hard to find. Strips of mainly small rounded stones remain after cannibalization of most medium and large stones from cultivation walls (Figure 13).

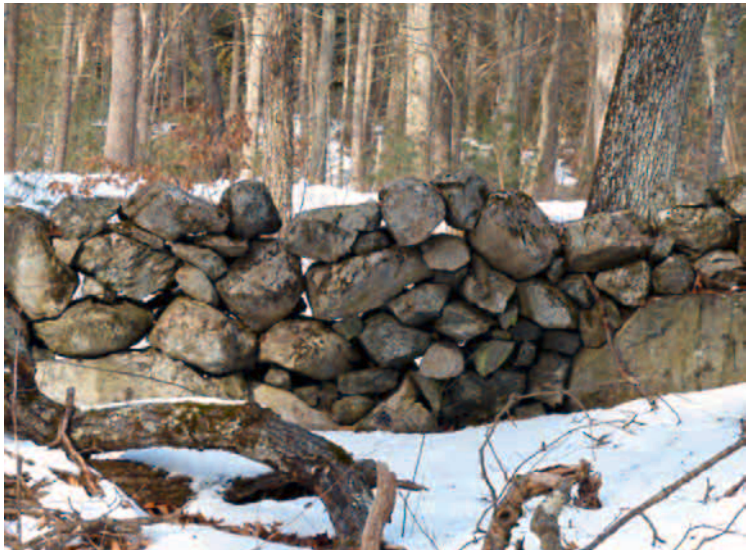
Figure 14
Later pasture wall. Single layer thick; spaces give a filagee look; small, medium, and large stones (some cut) at all levels; mostly granite and gneiss stones. CLCT Thornton Woods.

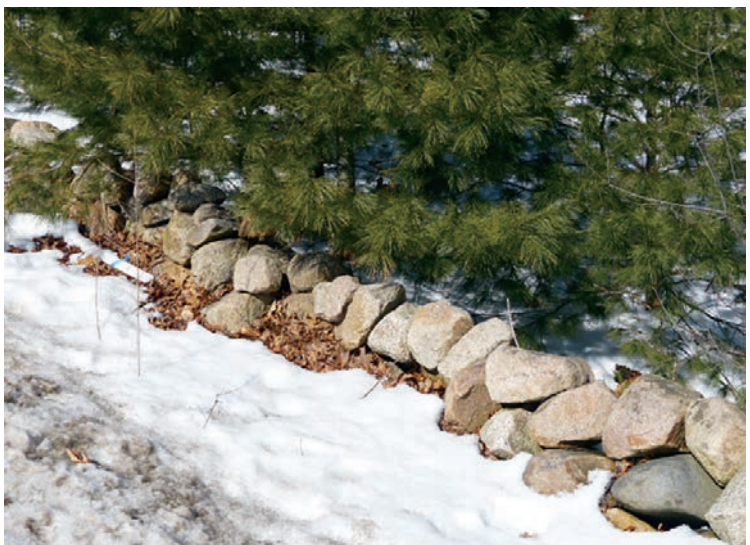
Figure 15
Low wall with small granite stones and no visible lichens. Accumulated leaves microhabitat. Wall built in 1990s, along Route 2A constructed here in 1806. USNPS, Lexington.

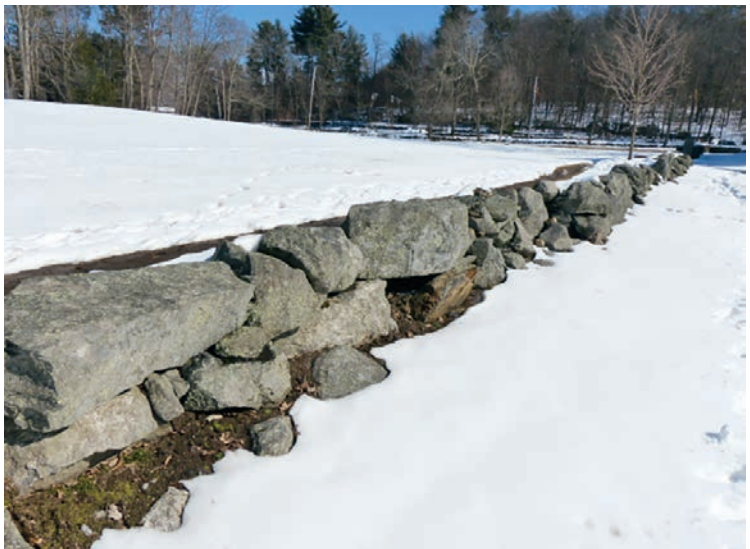
Figure 16
Broken-rocks wall with medium-size stones added. Several rocks (e.g., large central one) with 6-7" pneumatic-drill marks. Leaf accumulations. By The Trustees' Old Manse.

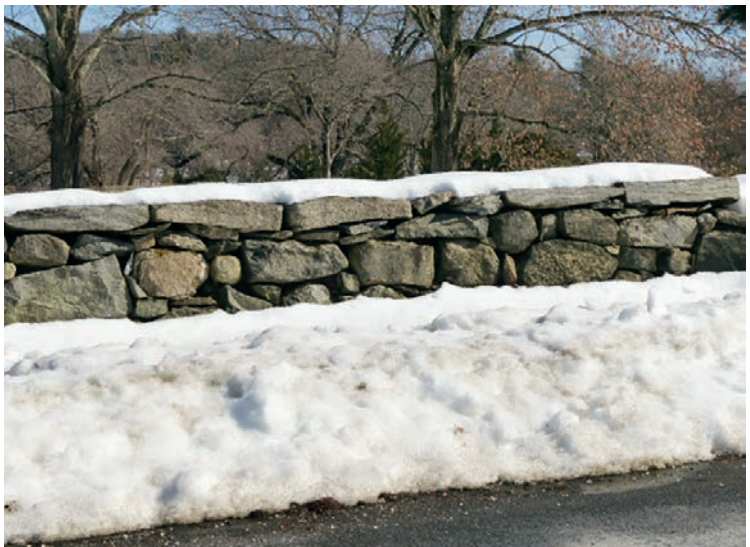
Figure 17
Flat-top wall with top layer of quarried flat stones. Heterogeneous mix of stones beneath from varied sources; includes many tiny exterior wedge stones. USNPS, Liberty St..

(1) Flat top walls (Figure 17); (2) walls with flat top-stones; (3) walls with many tiny exterior wedges (chinks); (4) a strip of jumbled stones with little or no structure; (5) masonry walls with mortar/cement; (6) machine-made walls; and (7) handsome, elegant walls in part for show (Figure 18).

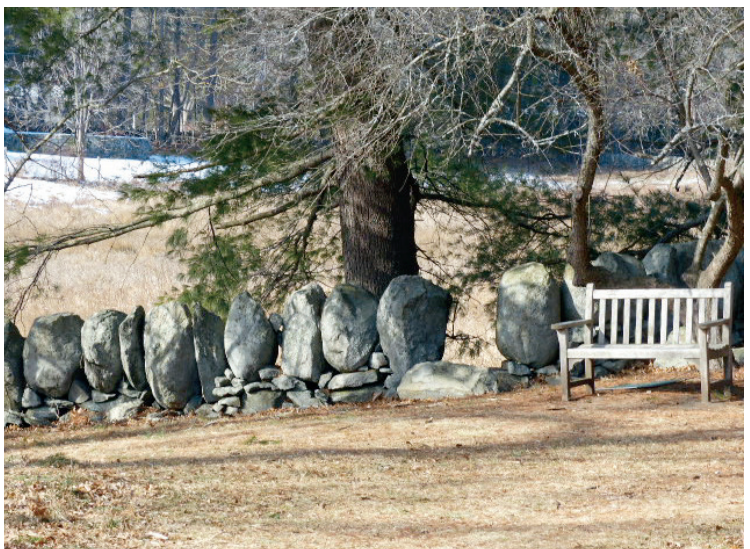
Figure 18
Decorative vertical-erratics stonewall. Two tiers, with basal stones arranged to create a constant height wall; built in the 1890s. CLCT Nashawtuc Hill, Shaw Land.
